Pool Systems USA, Inc  
**Water-Wand Cartridge Cleaner**  
**Technical Bulletin**

**Water-Wand**  
pool and spa cartridge filter cleaner

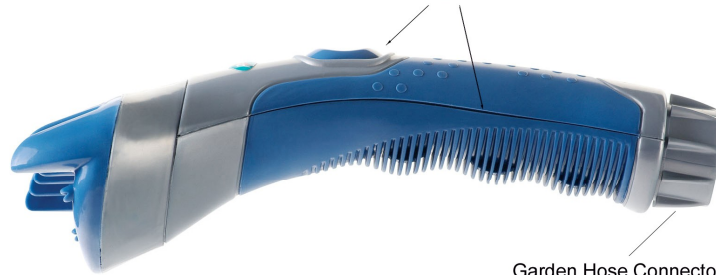
In almost every instance, this problem is the result of the garden hose not being correctly fitted to the unit.

The outer housing of the Water-Wand does not carry any water flow or water pressure. It is therefore highly unlikely that a leak in the product itself will develop here. The water is carried through a tube that runs up the inside of the housing.

Water will leak from these points if the garden hose is not secured firmly enough.

If the garden hose is not firmly secured to the product's garden hose connector, water will leak into the housing and out the various seams and openings. This problem is simply resolved by tightening up the garden hose connection.

Many garden hoses and their associated fittings vary in style. If you are having difficulty as a result of this, the use of an additional hose washer may help provide a perfect seal.

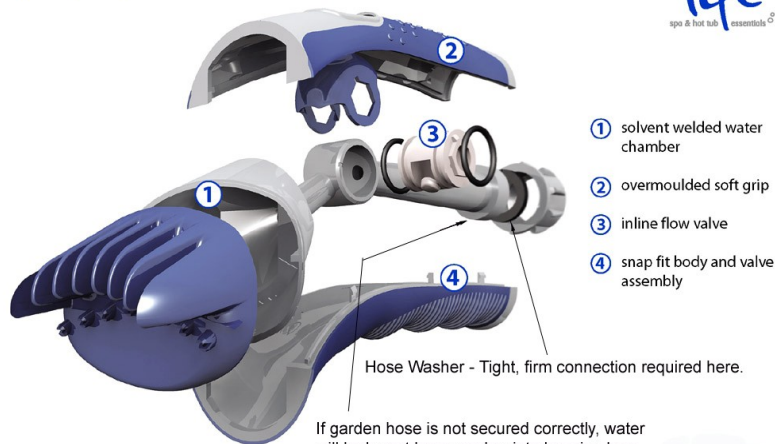
Garden Hose Connector - Must be secured tightly & firmly to the garden hose.
